Aviation Investigation Final Report

Location:	Miami, Florida	Accident Number:	DCA22FA132
Date & Time:	June 21, 2022, 21:38 UTC	Registration:	HI-1064
Aircraft:	McDonnell Douglas MD80	Aircraft Damage:	Substantial
Defining Event:	Landing gear collapse	Injuries:	4 Minor, 136 None
Flight Conducted Under:	Part 129: Foreign

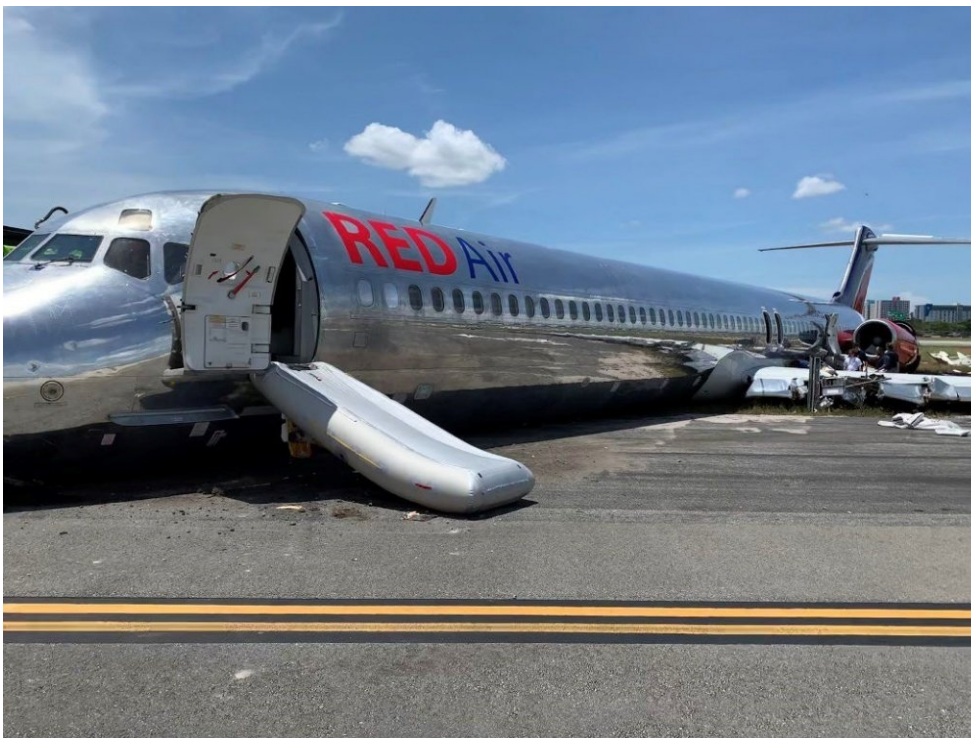
The airplane was found resting on its fuselage with all landing gear collapsed, as shown in figure 8. The L1 and L2 doors were opened with their evacuation slides fully inflated. The forward right overwing window exit and both left overwing window exits were opened. The R1 door, tailcone, and aft right overwing window exits were not opened.

Figure 8. Airplane resting location as viewed from the left side.

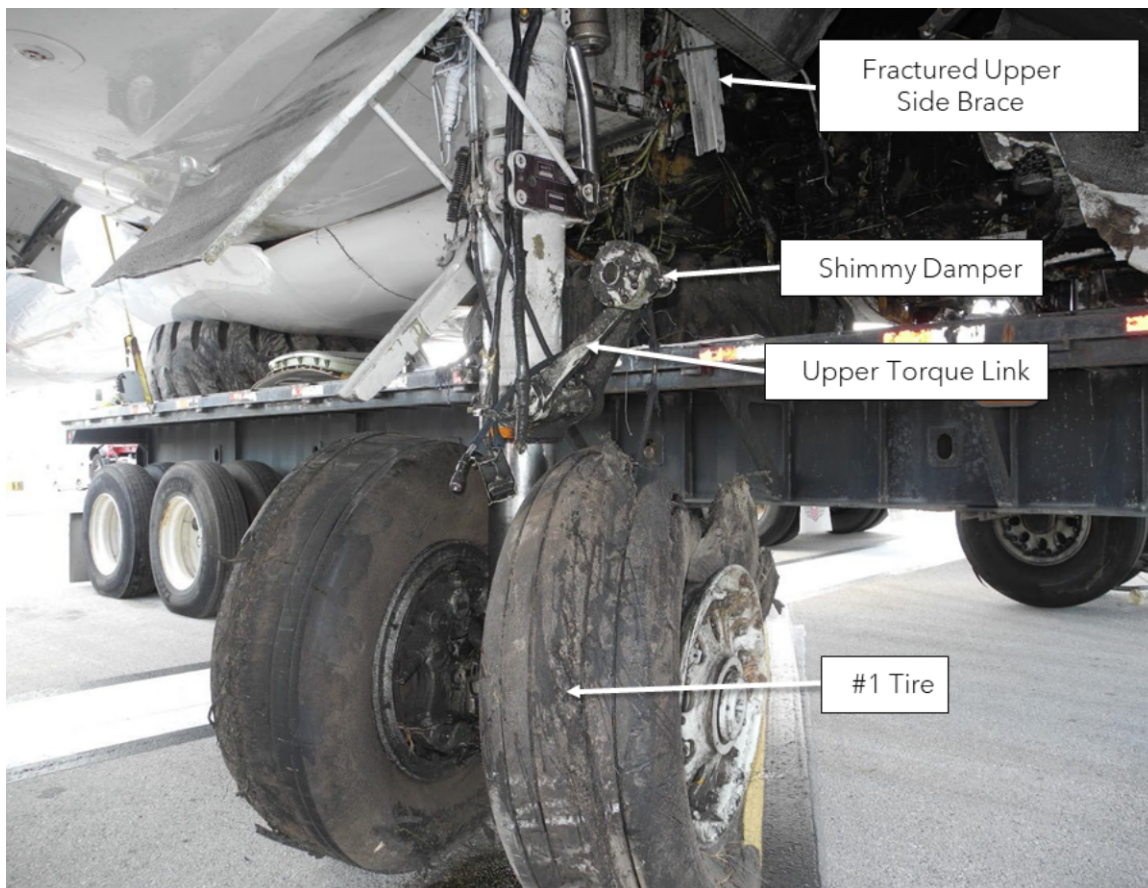
When the airplane was lifted during recovery, the left MLG dropped down to the extended position, and the axle was found to be rotated 90° outboard (with the No. 2 tire forward). The left MLG lower side brace fractured just below the joint of the upper and lower braces. The

lower end of the lower side brace remained attached to the outer cylinder. The upper side brace fractured into upper, middle, and lower pieces. The largest of the three pieces was the upper piece, which remained attached to the airplane (see figure 10). The middle and lower pieces were recovered in the debris field just past the glideslope building. The middle piece showed evidence of impact damage on its forward face. The lower piece had a small piece of black rubber, consistent with tire material, wedged in the joint.

Figure 10. Photo of the left main landing gear after the accident looking inboard and slightly forward. Note that the landing gear assembly is facing outboard in the photo.

Further examination of the left MLG found that all the fractures in the side braces and torque links occurred due to ductile separation consistent with overload; no evidence indicated fatigue failure. The damage on the forward side of the side brace aligned with damage on the outer cylinder near the gland nut, consistent with the side braces moving in the opposite direction of normal. The lower lock link was bent in the aft direction and was sheared. A small segment of the lower lock link, measuring about 3/16 inch, was missing. The upper lock link was bent in the forward direction with corresponding contact marks on the upper lock link and outer cylinder.

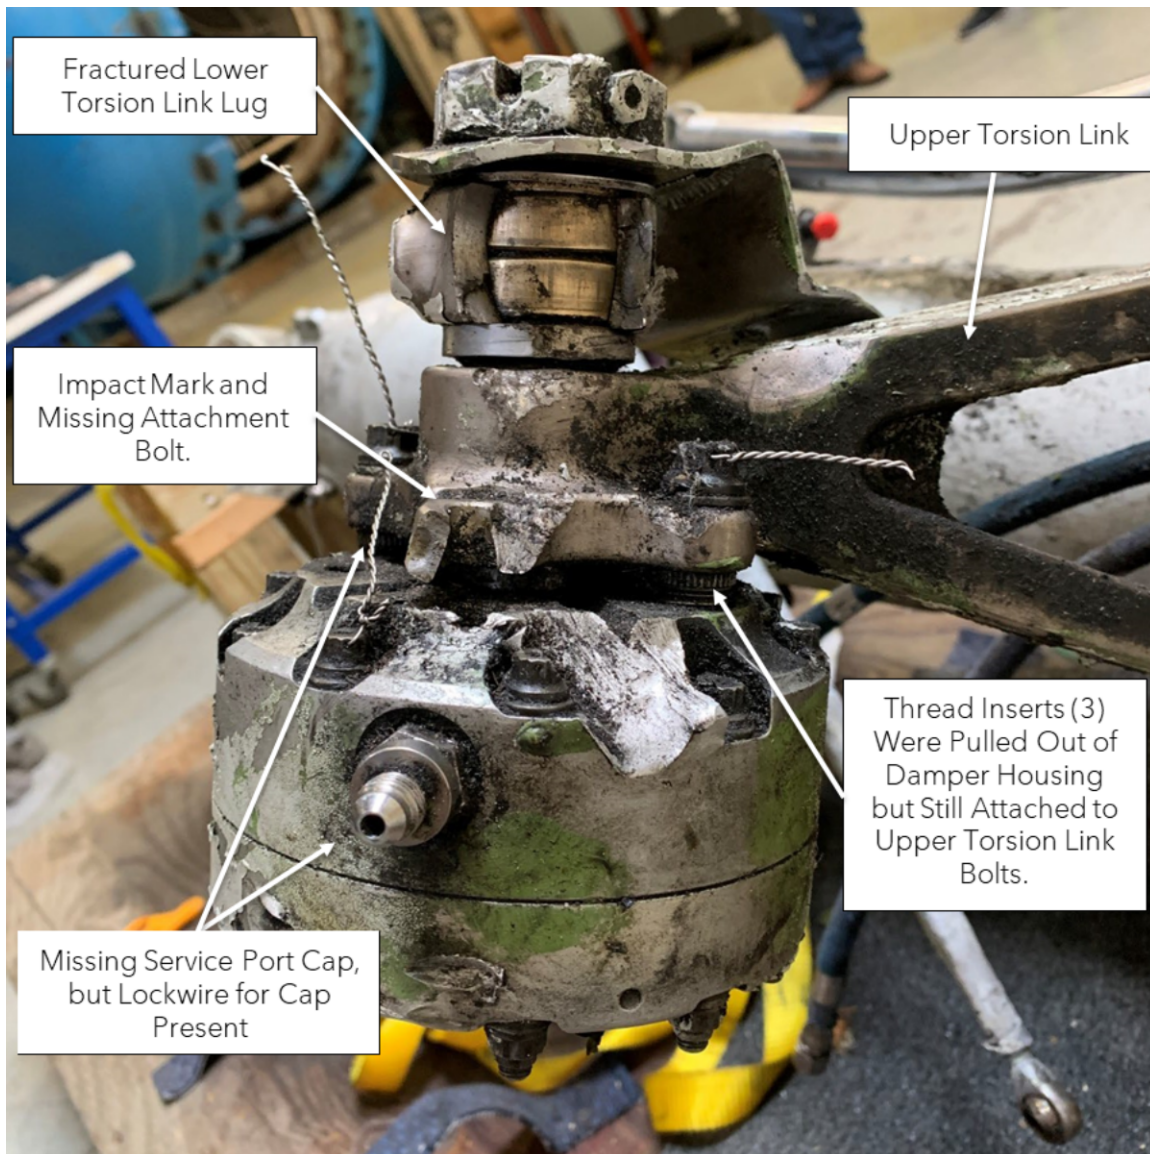
The left shimmy damper was examined and found to be assembled correctly. However, the check valve was found to be leaking and the cap for the check valve service port was missing. The damper requires sufficient hydraulic fluid to adequately dampen normal vibrations in the

system. For a significant amount of fluid to leave the damper, there would have to be failure of both the check valve and the cap for the service port.

Damage to check valves typically occur during servicing and any leaks would occur following a servicing event. Considering the last documented servicing of the shimmy damper occurred 1 year prior to the accident, it is likely that the check valve leak had silently developed and was sitting latent until a problem with the service port cap occurred.

The shimmy damper on the left MLG was missing its service port cap and hydraulic reservoir (see figure 11). The reservoir pieces were subsequently found in the grass area located about 200 ft north of the runway 9 centerline. The area where the reservoir was threaded into the damper housing had a large impact mark that deformed the area, and the threads were stripped.

Figure 11. Left main landing gear shimmy damper as recovered.

Further examination of the shimmy damper revealed impact damage to the cap, housing, and several of the 10 housing bolts. Each bolt was numbered clockwise, with No. 1 as the bolt in the 9:00 position, and the reservoir was at the 12:00 position as viewed from the cap side. Breakout torque was measured for each housing bolt. The specified torque was between 116 and 126 inch-pounds, but none of the measured torques were within that range.

The cap was removed, and the components on the cap side of the piston were removed and examined. All parts were found to be correctly installed and showed no apparent damage except for one of the five Belleville washers (the second one from the piston face), which was fractured due to ductile separation. The passages between the inner and outer orifices on the piston head were checked (with pressurized air) and found to be open.

The check valve/service port was removed from the housing, and the valve cap was not present. A lockwire was found on the nut for bolt No. 8 with an intact loop on the end that would have been connected to the service port cap. Breakaway torque was measured at 259 inch-pounds; nominal breakaway torque was 80 to 100 inch-pounds. The check valve passed the 5-pounds per square inch gauge (psig) allowable leakage rate test but failed the test performed at 1,000 psig. The valve was then cleaned, and the leakage tests were repeated, with the valve failing the tests at 5 and 1,000 psig. (The first test at 5 psig had a leakage rate of one drop/3 minutes, and the failed test at 5 psig had a leakage rate of two drops/3 minutes.)

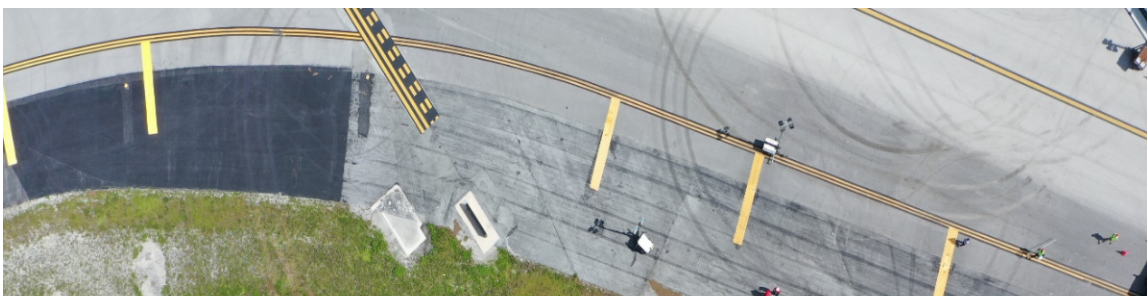
There was a post-crash fire as a result of the right-wing making contact with a concrete and steel structure in the grassy area to the left of the runway. See the emergency response section for more details on the response to the fire.

Figure 12. Overhead image of the wreckage captured by NTSB’s small UAS. The fire damage to the right wing is indicated by the yellow circle.
