Aviation Investigation Final Report

Location:	Miami, Florida	Accident Number:	DCA22FA132
Date & Time:	June 21, 2022, 21:38 UTC	Registration:	HI-1064
Aircraft:	McDonnell Douglas MD80	Aircraft Damage:	Substantial
Defining Event:	Landing gear collapse	Injuries:	4 Minor, 136 None
Flight Conducted Under:	Part 129: Foreign

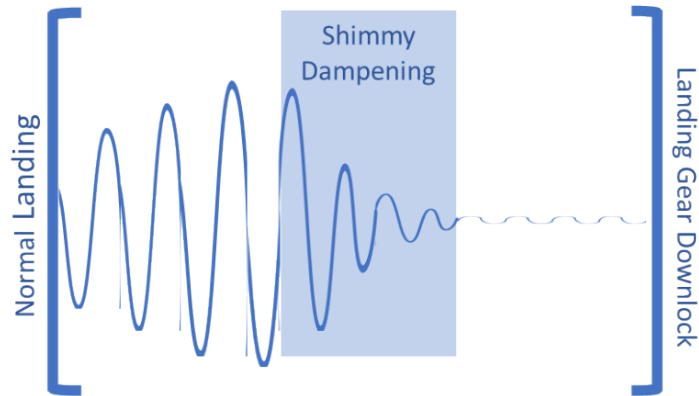
The focus of this analysis is the cause of the left main landing gear collapse. Particularly (1) the left shimmy damper's failure to adequately dampen vibration during landing and (2) the failure of the left main gear downlock mechanism due to excessive vibration. Figure 1 is a representation of how vibrations are typically dampened by a fully functioning shimmy damper. Figure 2 shows the rubber tire transfer markings that indicate the left main landing gear was shimmying down the runway.

Figure 1. The blue line is a representation of vibrations from a normal landing dampened by normally operating shimmy dampers when both main landing gear are down and locked. Note: Figure is not to scale nor depicting actual data.

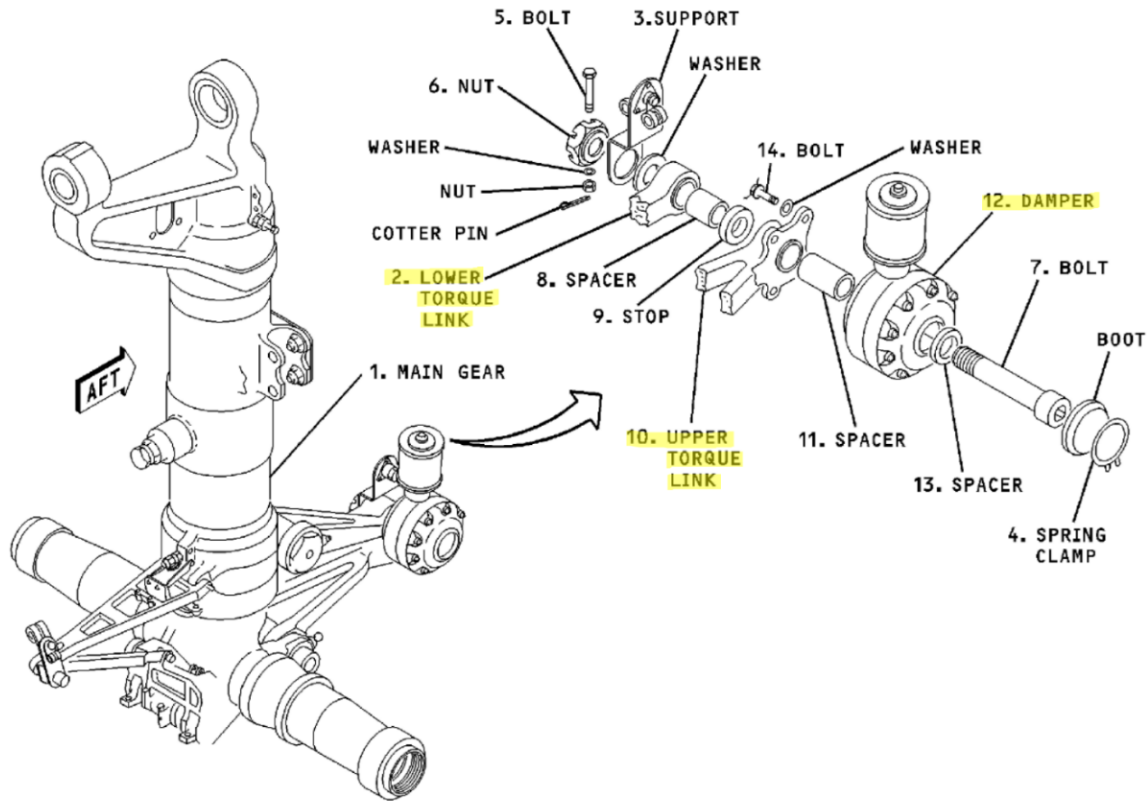
The airplane is equipped with shimmy dampers on both MLGs to prevent excessive vibration or shimmy buildup in the gear during high-speed taxi and heavy braking. The shimmy damper is connected between the upper and lower torque links and allows a small but highly damped motion to occur around the torsional axis of the gear. Shimmy damper effectiveness is maximized when the MLG strut is compressed. Limited dampening capability is available when the MLG strut is fully extended. Figure 5 shows the landing gear torque links and the shimmy damper installation.

Figure 5. Shimmy damper installation. (Image copyright © Boeing. Reproduced with permission, highlighting added for emphasis).
